Re: June 2011 Monthly Progress Report
Administrative Settlement Agreement and Order on Consent for Removal Action
U.S. EPA Region 10 Docket No. CERCLA 10-2009-0255
Gasco Sediments Site within the Portland Harbor Superfund Site

Attachment A Monthly Visual Monitoring Report for Pilot Cap Vicinity

Visual Observations Log Form

Monitoring Period: Monthly (Year 5)—June 2011

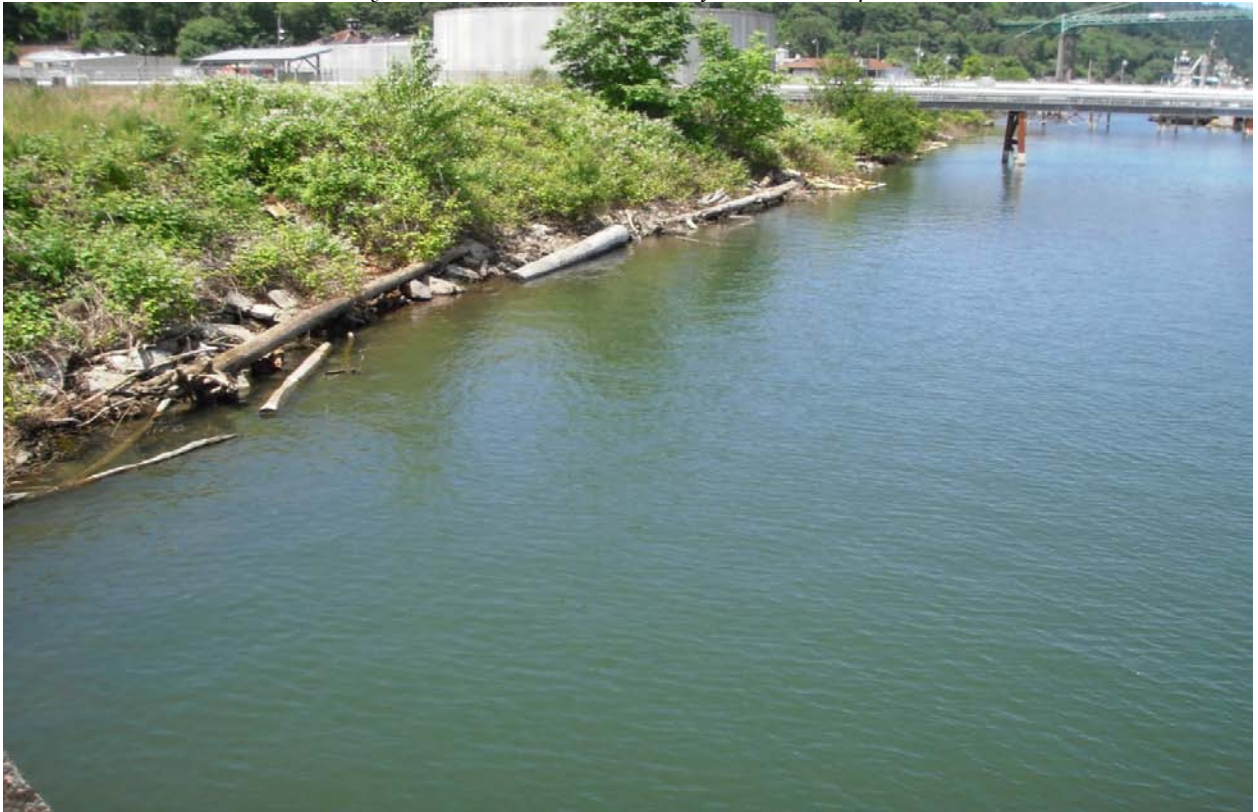
Observations of Erosion/Deposition: No erosion/deposition is evident along the shoreline. The shoreward extent of the cap was not visible. Due to high river water elevations, the exposed organoclay mat material observed in preceding events was not visible. (Photo 1).

Photo 1 — *River level currently elevated above the extent of sediment cap (06/21/11):*

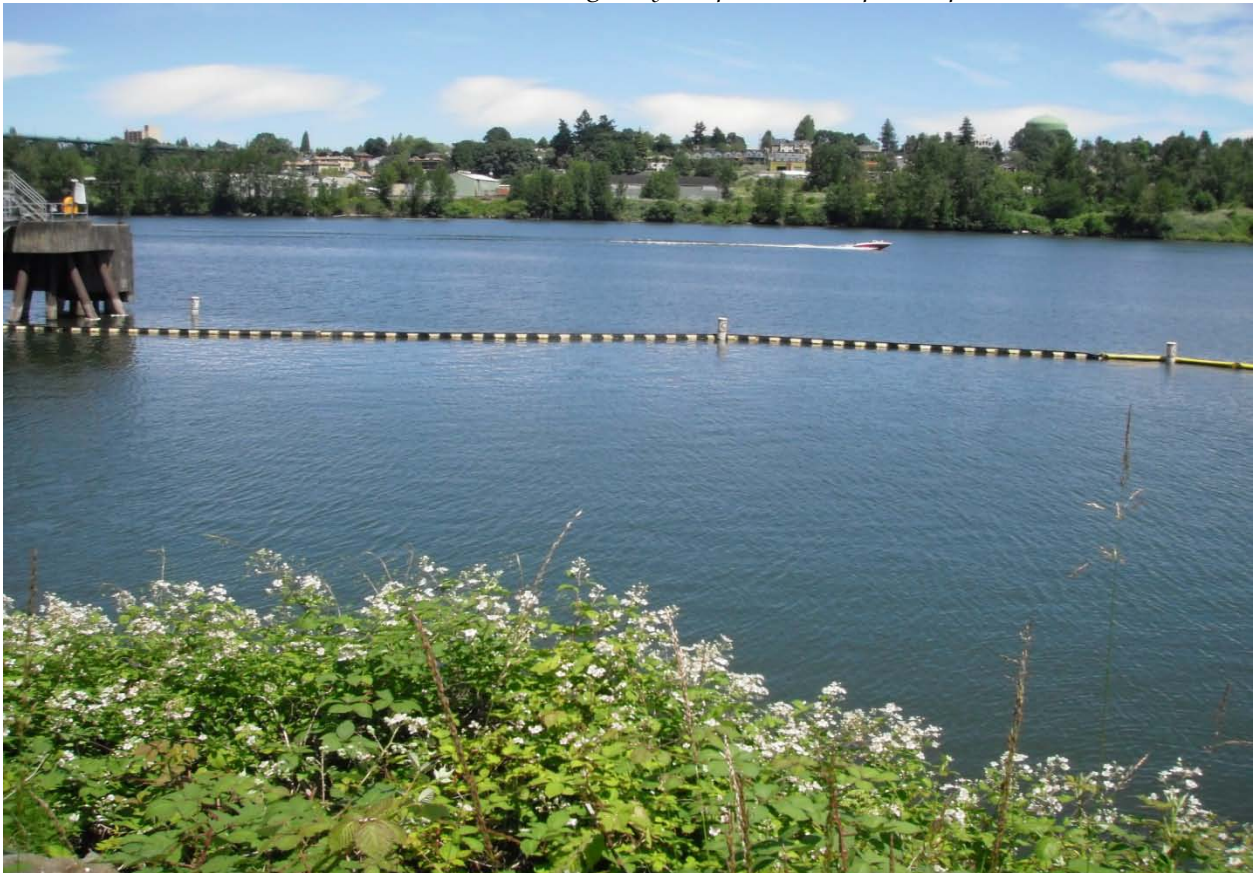
Observations of Long-term Controls (i.e., oil booms, organo-clay mat, etc.) The Fuel and Marine Marketing (FAMM) containment boom is positioned across the cap area, between the upriver corner of the ship dock and the wooden dolphin (near the upriver extent of the site and near the Siltronic Corporation outfall). Due to river levels, some wooden debris has gathered along the boom. Buoys that identify the cap area to mariners are in place as installed. The position of the FAMM oil boom, warning buoys and a general overview of the site shoreline are shown in Photo 2.

Photo 2 — *FAMM oil boom and mariner warning buoys in place across pilot cap area (06/21/11):*

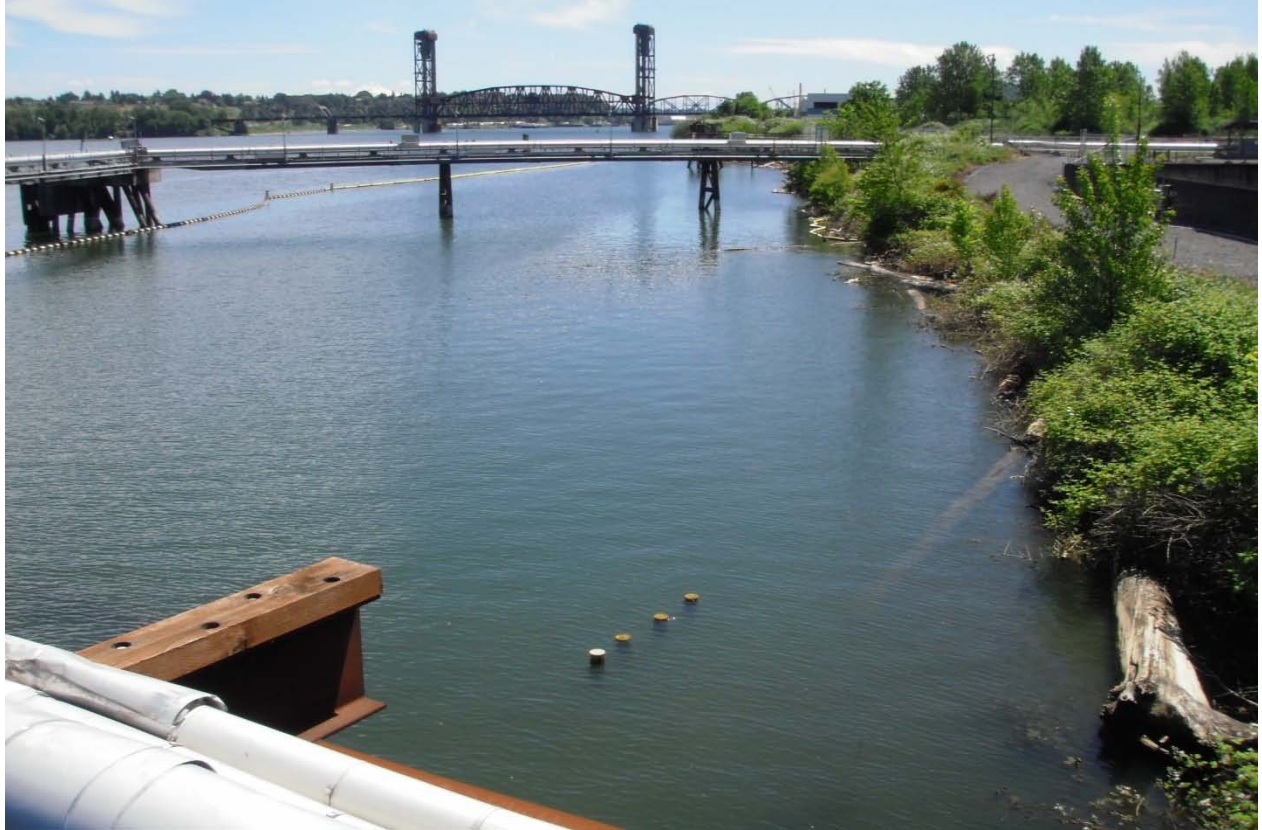
Other Comments: No sheen is evident in or around the cap area. Photo 3 shows the water surface and shoreline immediately downriver of the sediment cap.

Photo 3 — *Conditions immediately downriver of cap area (06/21/11):*
